**Preston Highlands North Estates**  
*Frisco, TX*

Report #: 54697-0

**RESERVE STUDY**  
**"Full"**

May 1, 2025

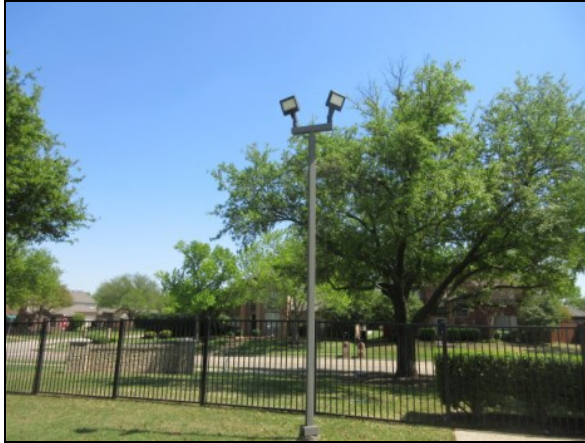
**Comp #: 345 Lighting: Poles - Replace**

20 years
