**Preston Highlands North Estates**  
*Frisco, TX*

Report #: 54697-0

**RESERVE STUDY**  
**"Full"**

May 1, 2025

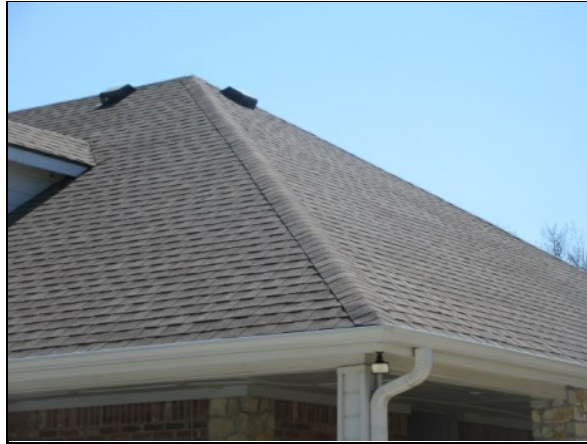
**Comp #: 1303 Roofing: Asphalt Shingle - Replace**

**History:** Replaced in 2022 for \$12,640

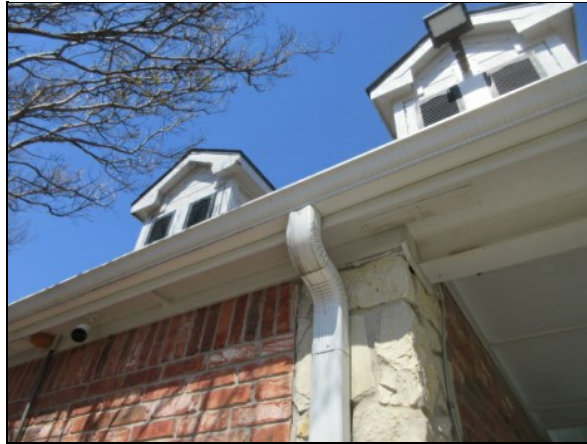
**Comp #: 1310 Gutters/Downspouts - Replace**

Good condition: Gutters and downspouts determined to be in good condition typically exhibit little to no significant surface wear or deterioration of material. No obvious sagging or tilting sections. Attachments to building appear to be strong and stable.

Gutters and downspouts are assumed to be functioning properly unless otherwise noted. As routine maintenance, inspect regularly, keep gutters and downspouts free of debris. If buildings are located near trees, keep trees trimmed back to avoid accumulation of leaves on the roof surface which will accumulate in the gutters and increase maintenance requirements while reducing life expectancy. Repair or replace individual sections as needed as an Operating expense. We generally recommend that the gutters and downspouts be replaced when the roof is being resurfaced/replaced. National Roofing Contractor Association (NRCA) roofing standard includes installing eave flashings at the gutters. We suggest to plan for total replacement of gutter and downspouts at the same intervals as roof replacement for cost efficiency. Unless otherwise noted, costs shown here assume replacement with similar type as are currently in place.

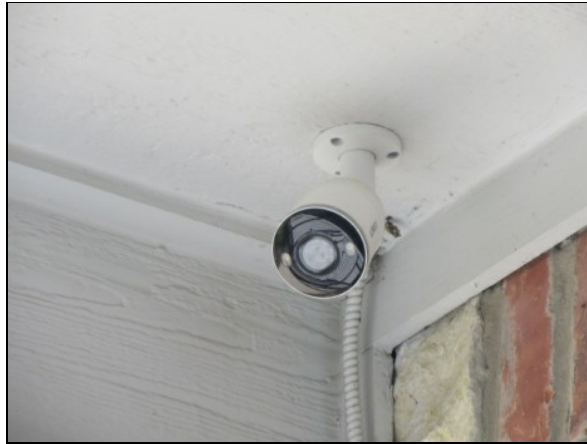
Security/surveillance system(s) should be monitored closely to ensure proper function. Whenever possible, camera locations should be protected and isolated to prevent tampering and/or theft. Typical modernization projects may include addition and/or replacement of cameras, recording equipment, monitors, software, etc. Costs assume that existing wiring can be re-used and only the actual equipment will be replaced. In many cases, replacement or modernization is warranted due to advancement in technology, not necessarily due to functional failure of the existing system. Keep track of any partial replacements and include cost history during future reserve study updates.

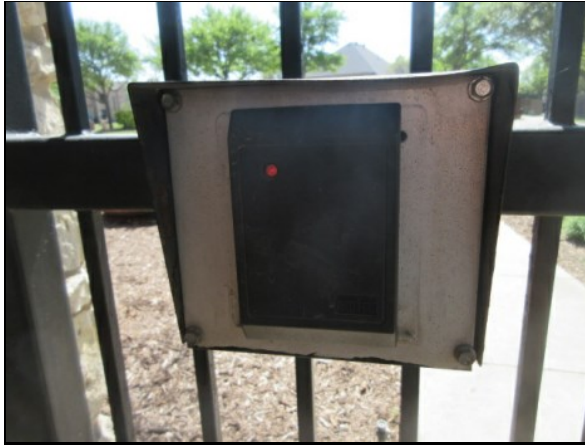
**History:** Card reader replaced in 2021 for \$500

Card/fob reader device(s) are assumed to be functional. Due to use, exposure, and advancements in technology, plan to replace devices and control systems at the approximate interval shown here. Individual readers can often be replaced as an operating expense due to damage or localized failures. To ensure a functional, compatible system and obtain better pricing, plan on replacing all devices together as one project.

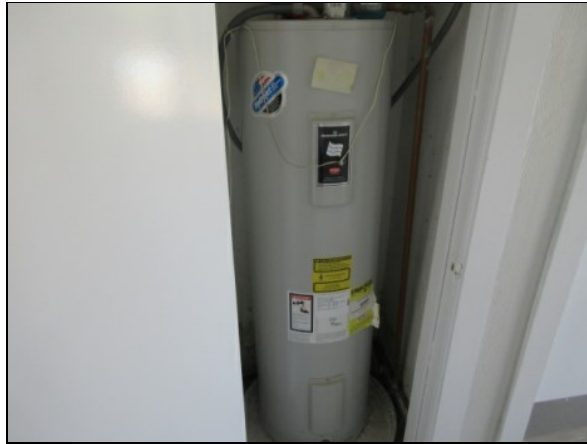
**Comp #: 803 Water Heater - Replace**

System was not tested during the inspection, but is assumed to be functional. Water heater life expectancies can vary greatly depending on level of use, type of technology, amount of preventive maintenance and other factors. Heater should be inspected and repaired as-needed by a vendor or maintenance staff as an operating expense. Even with ongoing maintenance and repairs considered, we recommend that the client financially prepare to replace at the approximate interval shown below. When evaluating replacements, we recommend choosing high-efficiency or tankless models if possible in order to minimize energy usage.
